INDOOR AIR QUALITY ASSESSMENT

**South River Elementary School
54 Hatch Street
Marshfield, Massachusetts**

Prepared by:
Massachusetts Department of Public Health
Bureau of Environmental Health
Indoor Air Quality Program
March 2008

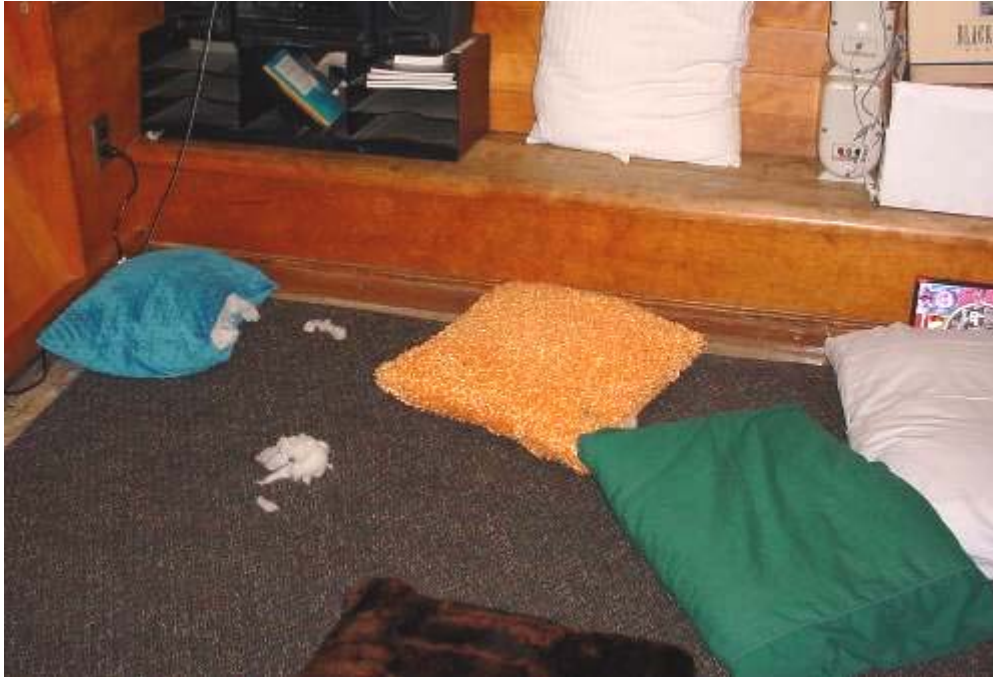
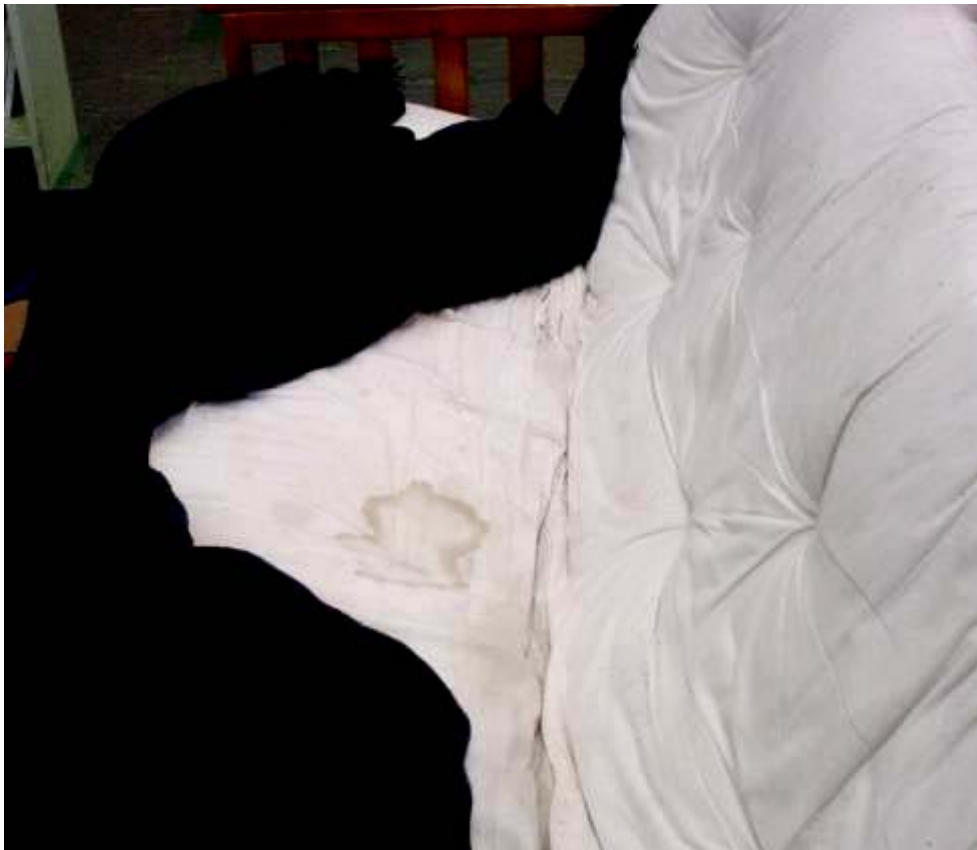
Finally, a number of classrooms contained upholstered furniture and pillows (Pictures 33 and 34). These items are covered with fabric that comes in contact with human skin, which can leave oils, perspiration, hair and skin cells. Dust mites feed upon human skin cells and excrete waste products that contain allergens. Furthermore, increased relative humidity levels above 60 percent can also perpetuate dust mite proliferation (US EPA, 1992). In order to remove dust mites and other pollutants, frequent vacuuming of upholstered furniture is recommended (Berry, 1994). It is also recommended that if upholstered furniture is present in schools, it should be

Pillows in Classroom, Note Damaged Pillow with Stuffing on Floor

Stained Furniture Cushion in Classroom

19. Store cleaning products properly and out of reach of students.
20. Clean upholstered furniture and pillows on the schedule recommended in this report. If not possible/practical, consider removal from classrooms.
